OKI B721/B731/MPS5501 Printer – Important Information Update

543 Toner Sensor Error after installing a new or replacement print cartridge into the printer. Check the print cartridge for the following problem before checking any other possible causes.

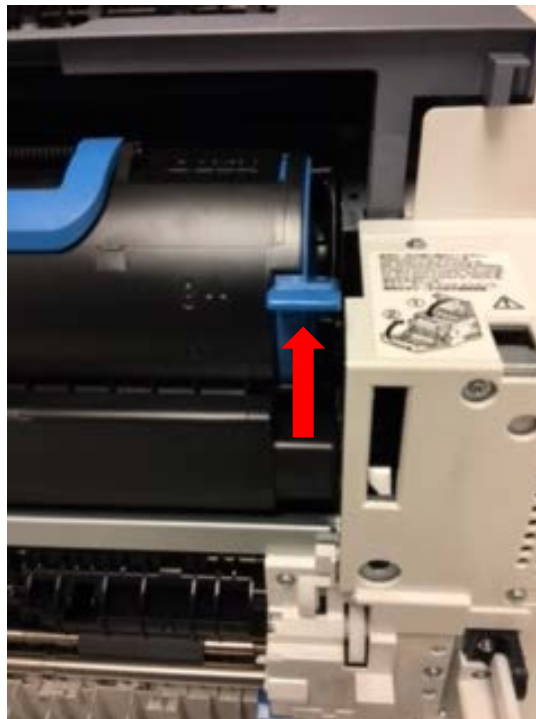
While the print cartridge is still installed in the printer confirm that the Blue Lock Lever is in the UP / Locked Position (see red arrow below).

Note: If the Blue Lock Lever is in the Down / Unlocked position when the print cartridge is installed in the printer the 543 Toner Sensor Error will appear.

Ensure blue lever is in up position, then close the front cover and see if the 543 Toner Sensor Error clears. If the error clears, there is no need to read beyond this point. Procedure completed.

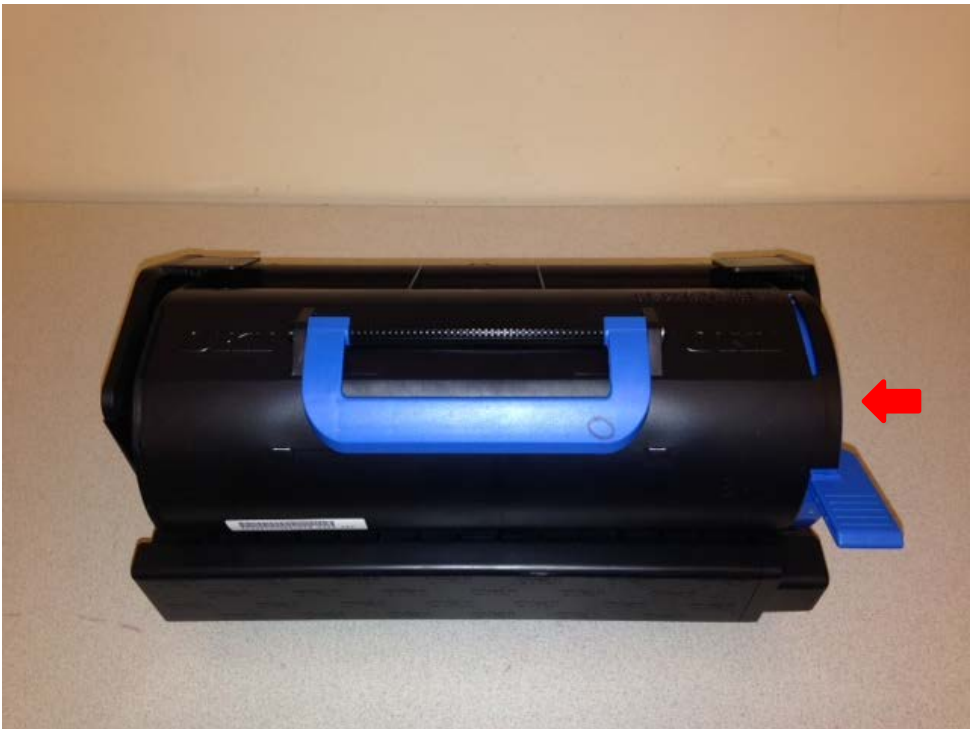
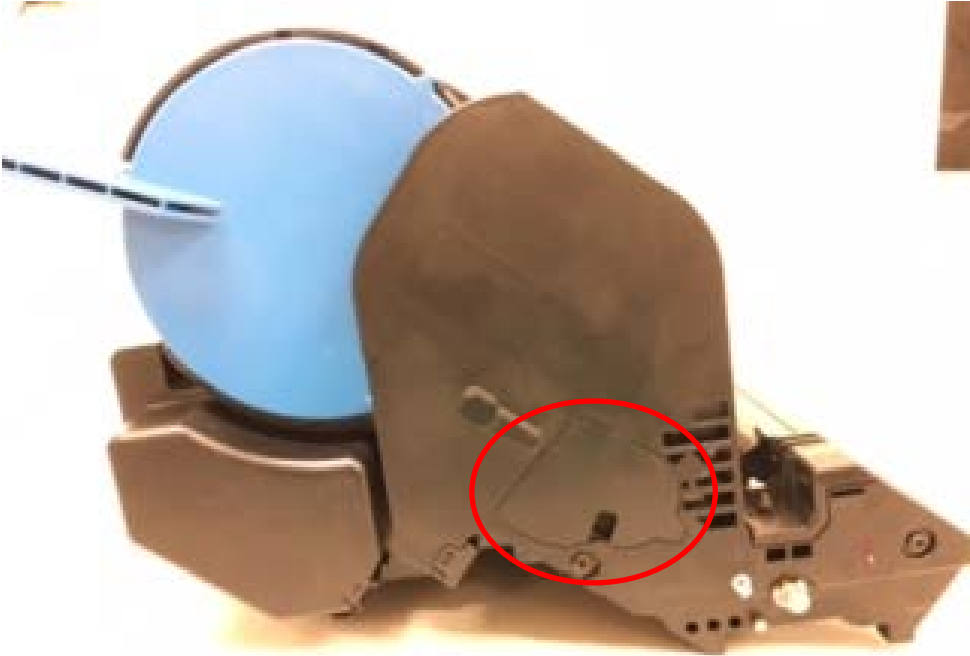
If the error persists remove the print cartridge from the printer and place it onto a flat surface. Look for the small access panel on the right side of the printer cartridge.

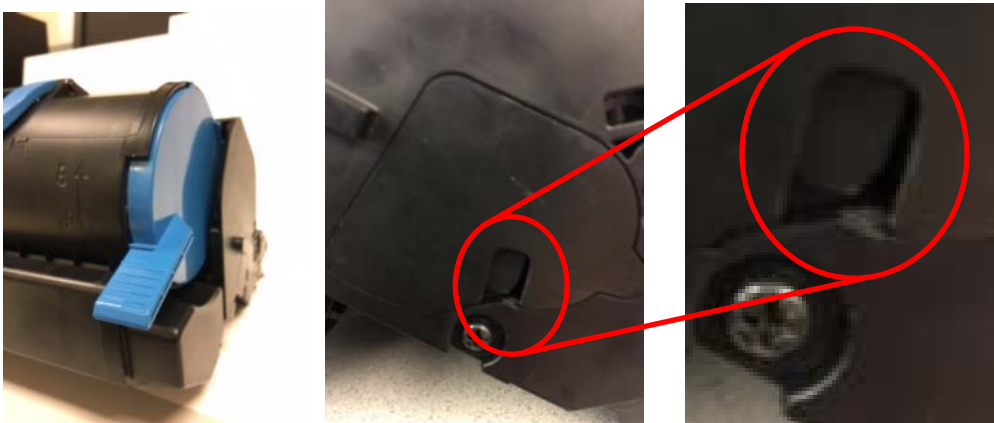
With the print cartridge sitting on the flat surface look into the small window in the access panel. Move the blue lock lever to the down / unlocked position. You should see the black lever behind the access panel blocking the small window (see red circles below).

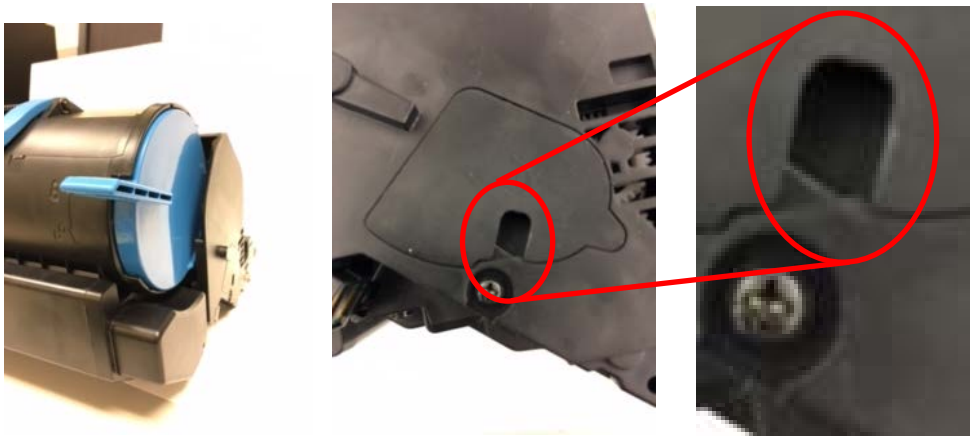
Now move the blue lock lever in the up / locked position. You should not see the black lever behind the access panel blocking the small window (see red circle below).

Based on above, the window is being blocked by the black lever, when the blue lock lever is in the up / locked position. This is the source of the 543 toner sensor error condition.

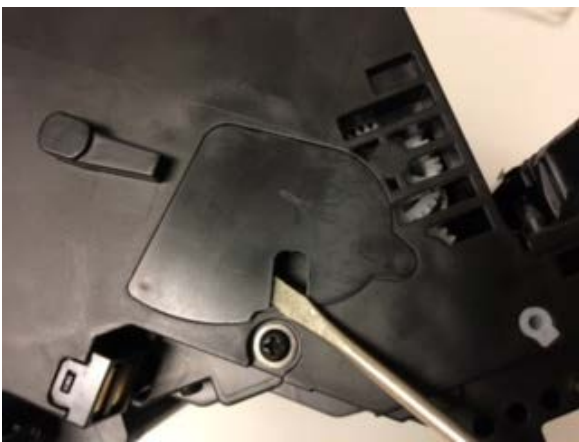
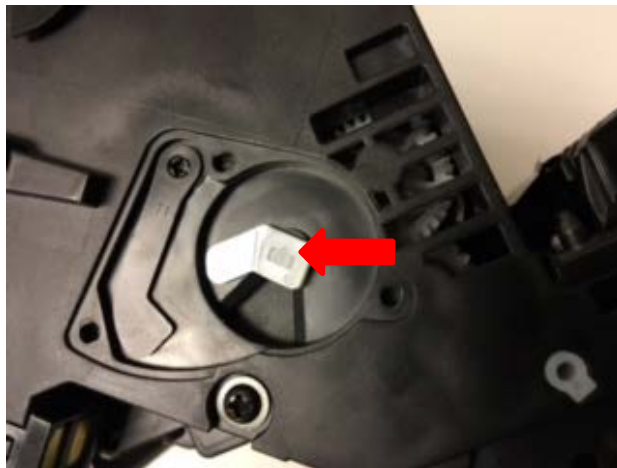
WARNING: Do not insert the screwdriver blade too far into the opening as you could lift the light colored toner flag off of its mounting (see red arrow below).

Carefully insert a screw driver blade into the opening to lift the access panel off of the print cartridge.

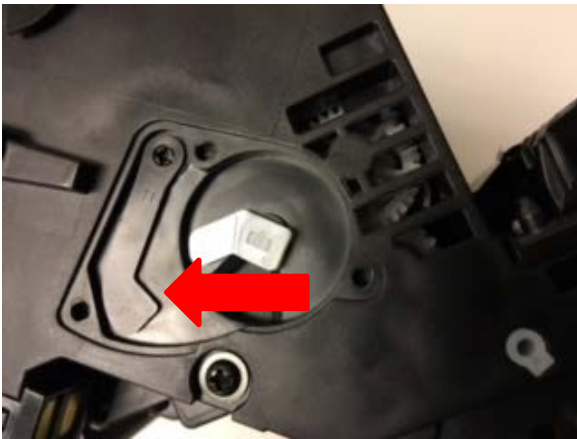
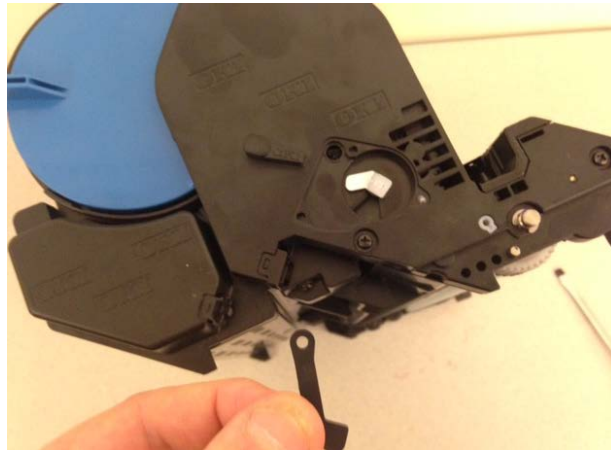
Once the access panel has been lifted off the print cartridge you can remove the malfunctioning black lever (see red arrow below).
